Advisory Visit undertaken by Gareth Pedley on behalf of the Wild Trout Trust for Sowerby Angling Society

Cod Beck

April 25th 2013

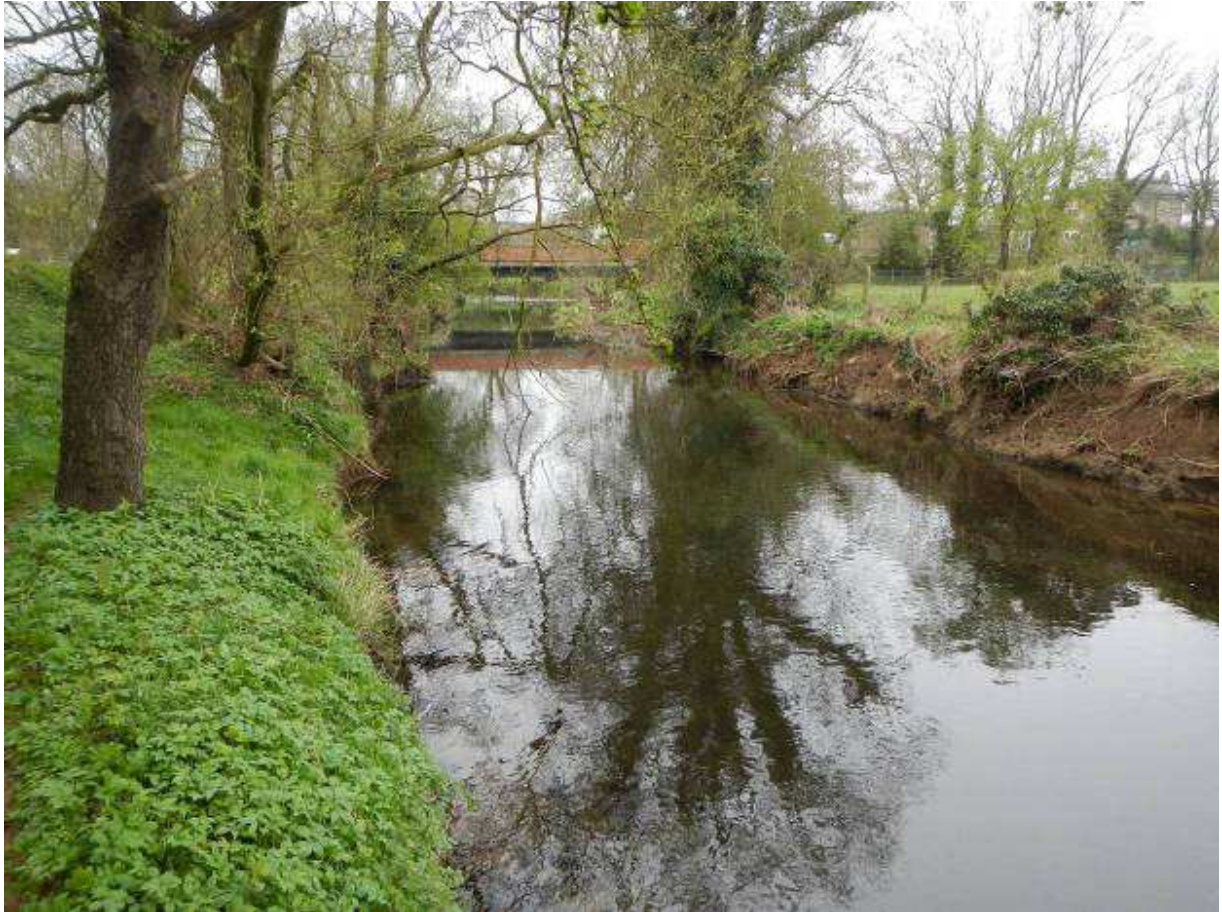
Heading upstream from the A168 the impacts of past modifications are clear to see. The channel is straight for long sections and greatly over-wide for the volume of flow it will receive in most conditions. Many of the vital, natural in-channel characteristics (pools, riffles and bars) are significantly degraded or removed (Figure 1).

Figure 1. Straightened and dredged section of river of poor habitat quality.

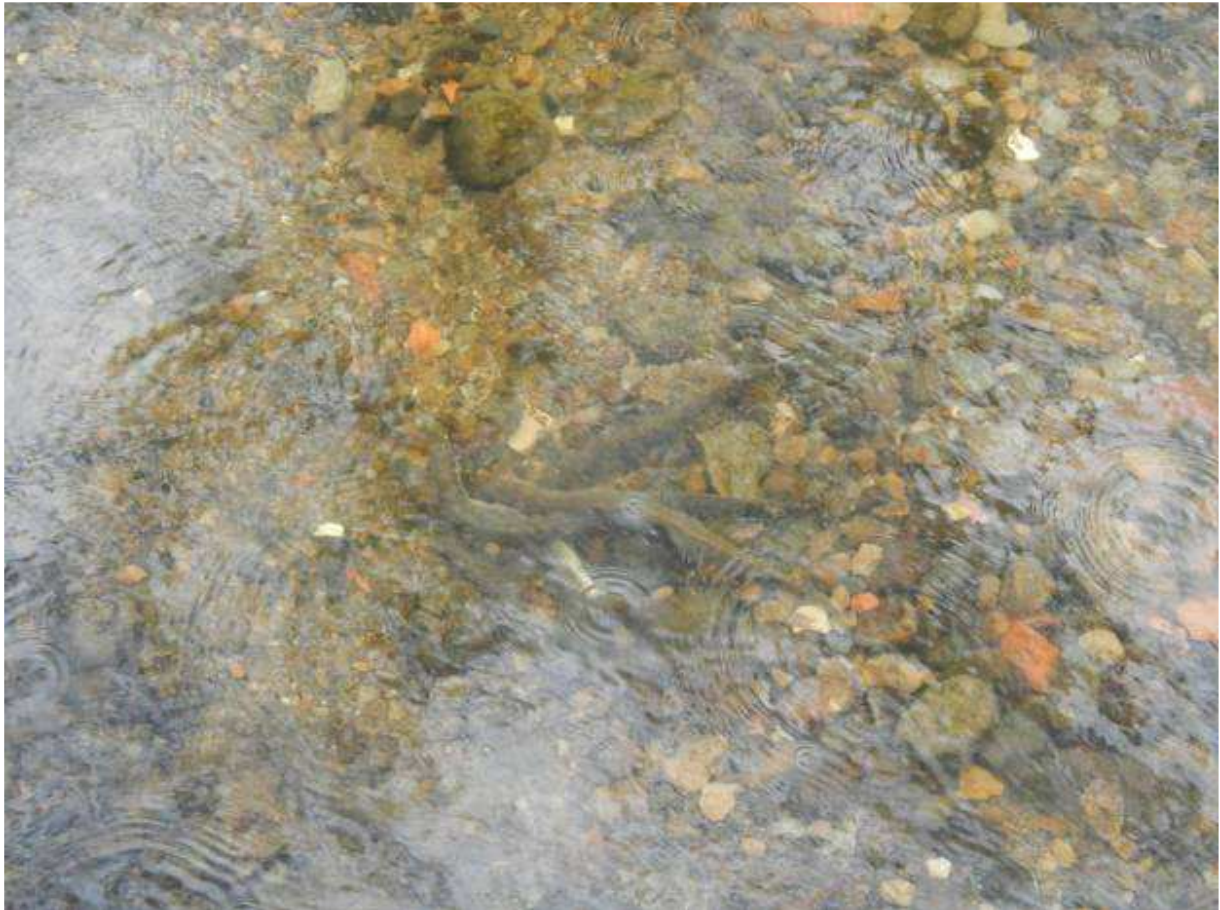
Numerous lamprey spawning sites were, however, observed throughout Sowerby AS waters (Figure 2), which was an encouraging sign and demonstrates some degree of healthy biodiversity. Their activity also demonstrated the presence of potential salmonid spawning substrate in some areas, if it could be enhanced. Protection of lamprey spawning sites is

Figure 2. Lamprey spawning, revealing substrate well within the requirements of salmonids if it could be cleaned and sorted.

The numerous lamprey spawning sites encountered on the day of the advisory visit highlights the importance of this area of the Beck for lamprey. As an important native species it is therefore important to ensure that angling activity does not negatively impact upon the lamprey. With this in mind it is recommended that all Sowerby AS members are advised to avoid walking on lamprey redds if fishing the river in spring (April/May), in the same way they would avoid salmonid redds if fishing outside of the trout season. The lamprey redds can be easily identified as areas of clean gravel, with aggregations of similar sized larger gravels, usually covering an area of c.300-500mm dia.

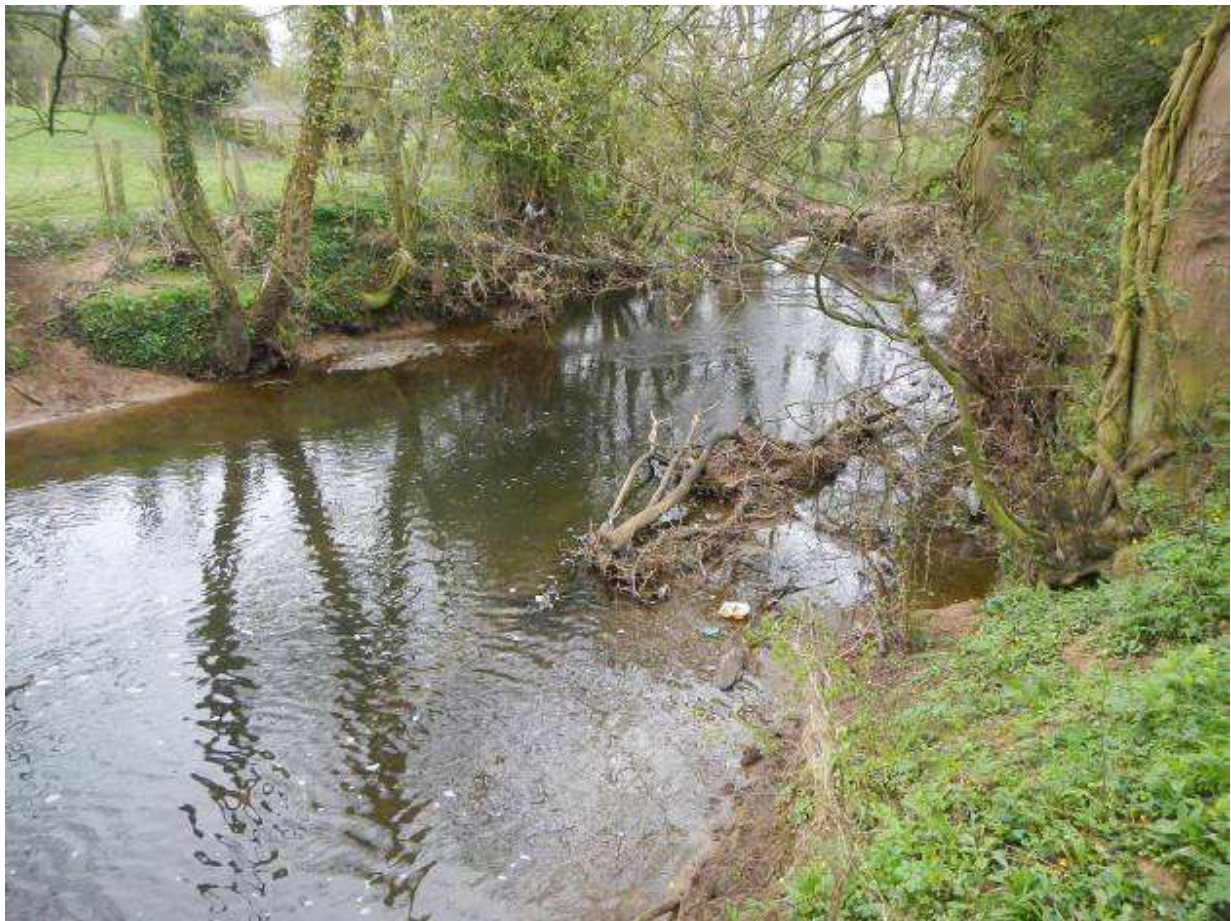
Figure 3. Some of the better quality habitat observed. Woody debris in the foreground is encouraging deposition and creating natural channel narrowing, which in turn has scoured a deeper pool in the central channel. Bank side trees provide good cover from low branches and roots.

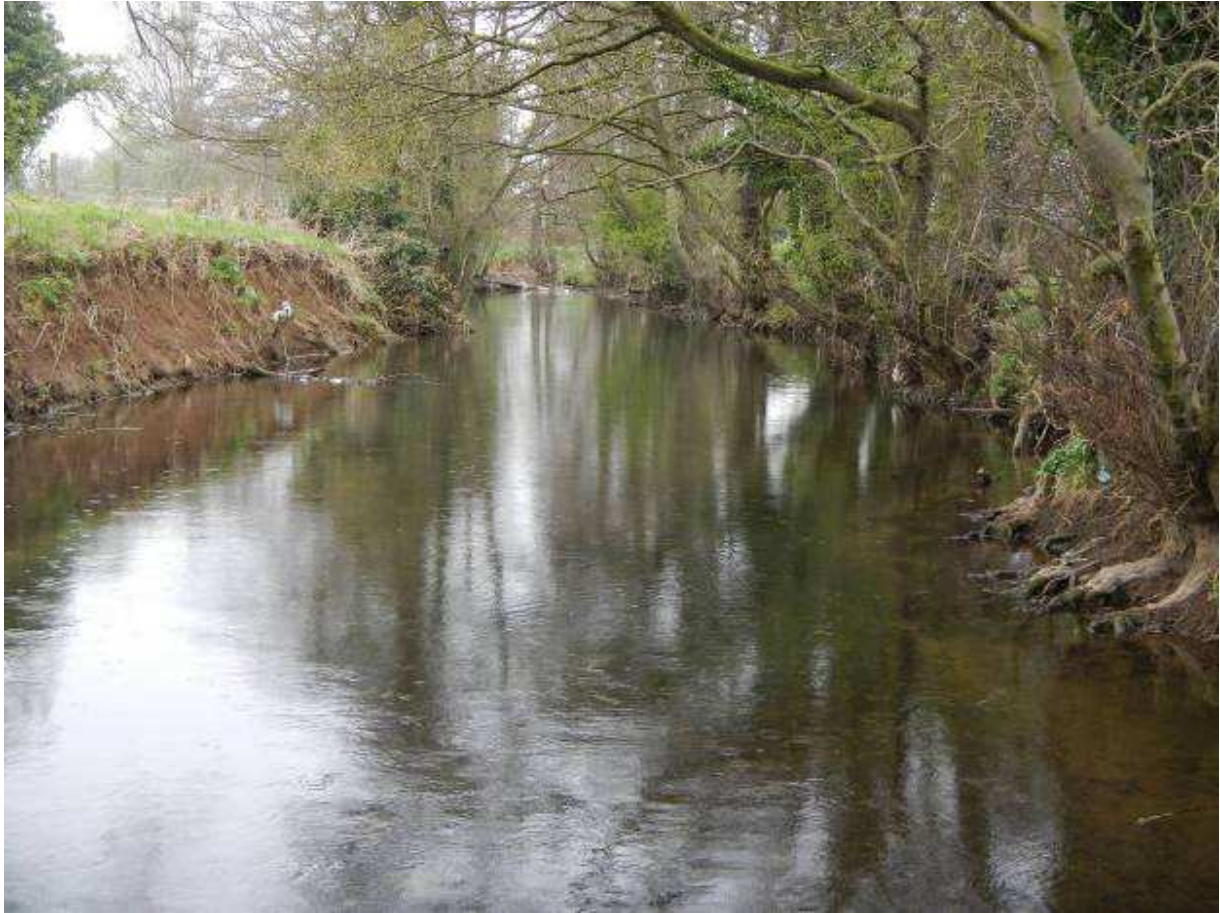
In addition to the issues of channel modification, a lack of low-level aerial, and trailing cover habitat, and scarcity of large wood debris was also noted in many areas (Figure 4). This is likely down to two issues, historic channel maintenance by the Environment Agency (EA), to reduce the potential for blockages and improve flood conveyance, or pruning by anglers.

Figure 4. An overly-straight and long pool, with little depth or flow variability. Also note the lack of low-level and trailing cover.

To enhance habitat in these areas the ideal solution is increasing the availability of low-level and in-channel structures by selective coppicing of suitable species (willows *Salix spp*, alder *Alnus glutinosa*, hazel *Corylus avellana*, elm *Ulmus minor* and sycamore *Acer pseudoplatanus*), along with laying (as you would lay hawthorn for a hedge) willow, hazel and elm into the channel along the river bank (Figure 5).

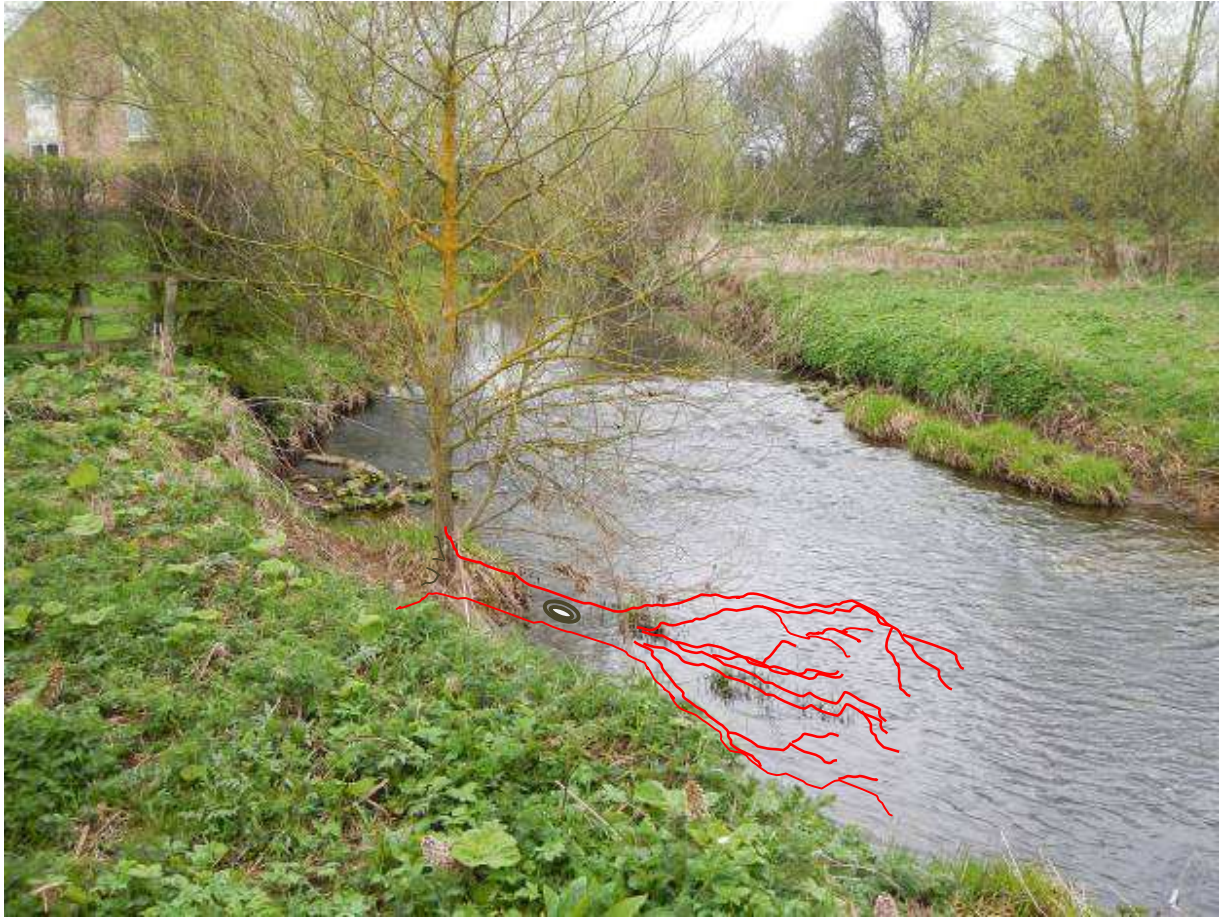
Figure 5. Good juvenile habitat provided by a shallow riffle with trailing and emergent vegetation in the margins. This habitat could be further enhanced by laying the willow down along the toe of the bank, as demonstrated in red. The same technique would be very beneficial in many areas where willow, hazel and elm are present along the bank.

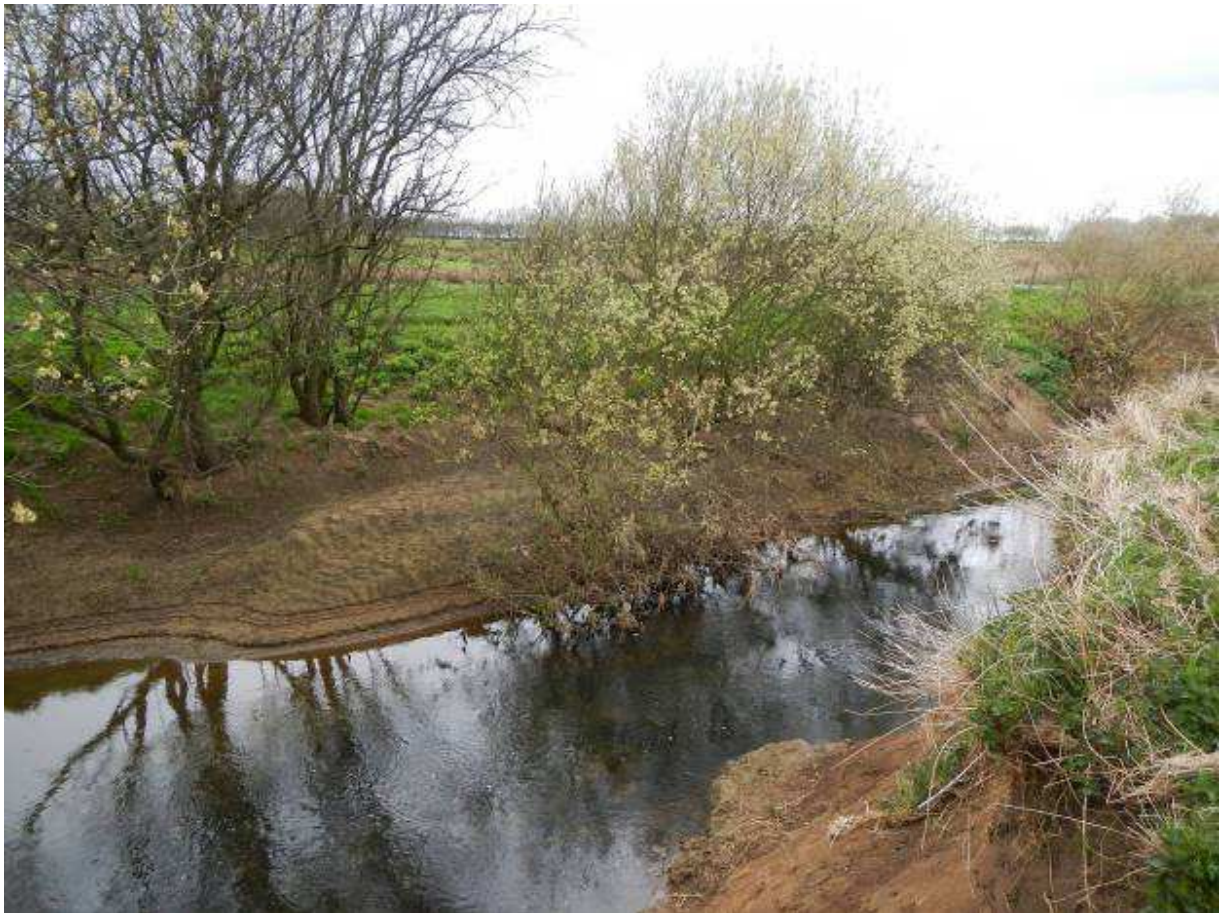
Figure 6. Significant depositions of sediment on the far bank, showing the high volumes present within the watercourse and the potential for in-channel structure to baffle and slow flows, assisting deposition.

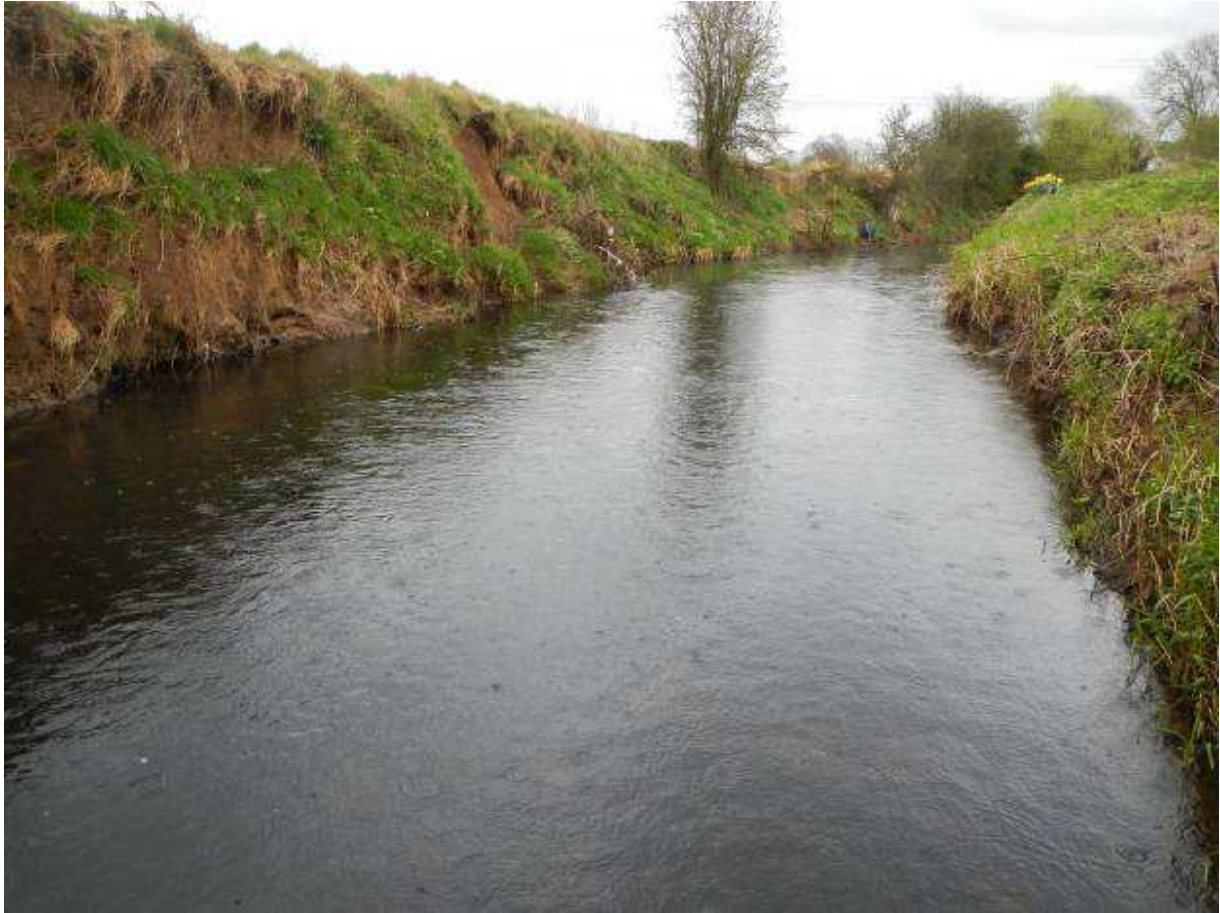
Several long, straight areas of channel were observed in this section (Figure 7), all of which could be enhanced in the short-term by increasing in-channel structure, particularly paired upstream deflectors. In addition to deflectors, planting of willow along the average water line would increase cover and provide living structure within the bank that will help to provide additional longer-term benefits to the flow deflectors. In particular, planting around the base of the deflectors, and slightly up and downstream will help capitalise upon any marginal deposition the deflectors encourage. They can then be laid into the channel in future, to replace the deflectors, or coppiced to retain low branch cover as required. Planting of willow in all locations where a lack of cover exists would be beneficial, but particularly where exposed and eroding banks are present, as their roots will help bind the banks together and reduce erosion, as on the RB (left of shot) in figure 7.

Figure 7. Overly straight section where upstream flow deflectors could be employed to focus flows to the centre of the channel to scour deeper areas while cleaning and sorting gravels.

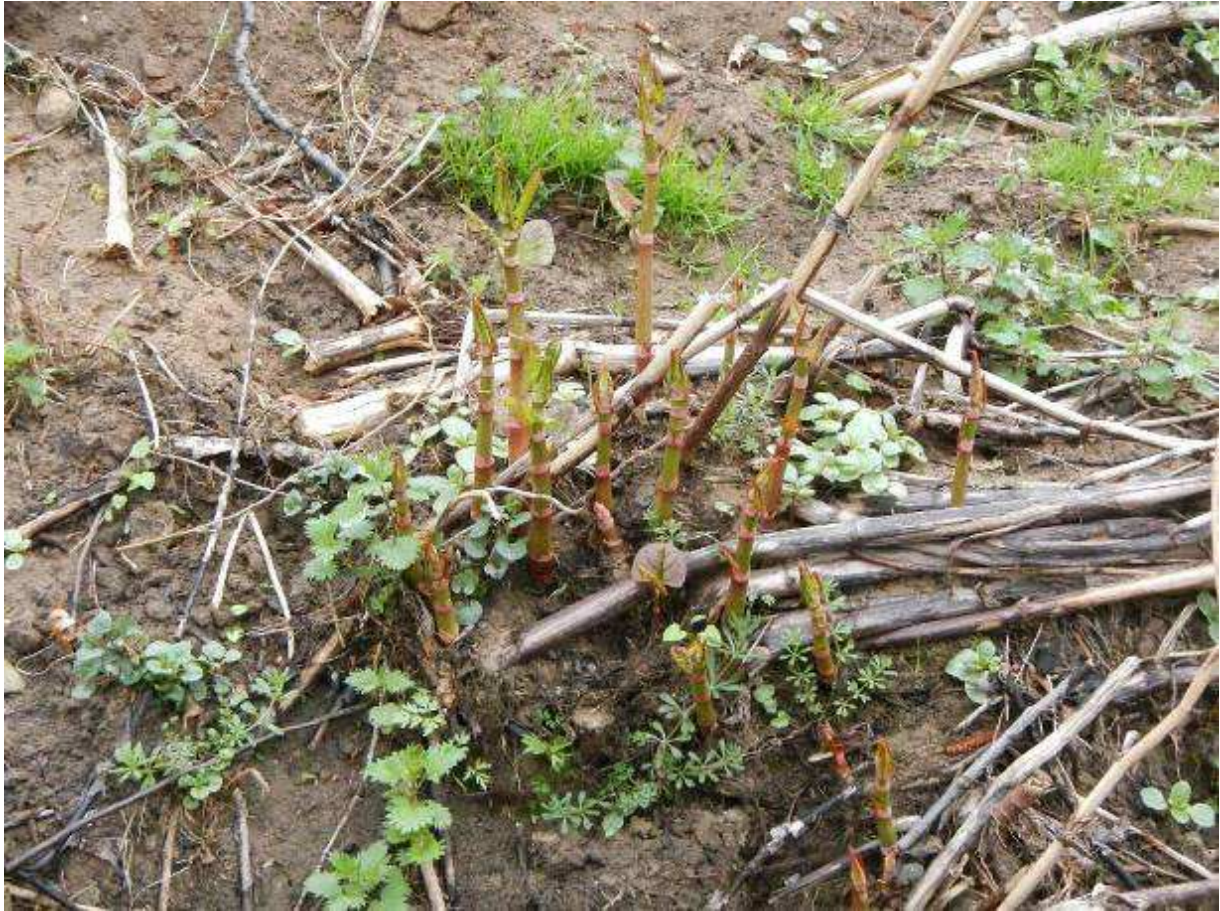
Figure 8. Small stand of Japanese knotweed (NGR - SE4363180155), which should be treated as soon as possible to stop it becoming established and spreading.

The other method is the use of the herbicide glyphosate, which is also the only effective method to tackle Japanese knotweed; however, its use by watercourses requires consent from the EA (more information on this can be found on the EA website).

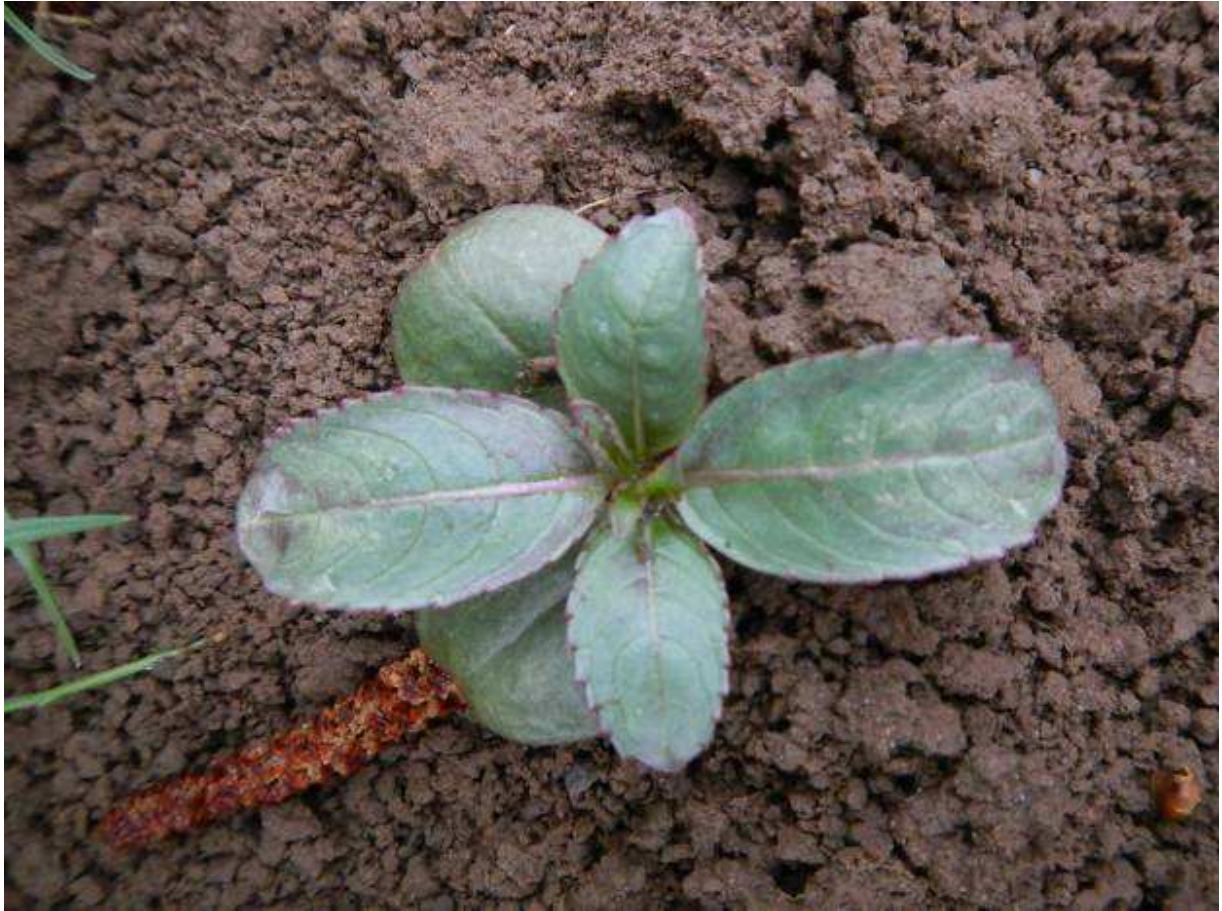
Figure 9. Newly sprouted Himalayan balsam plant.

It is strongly advised that stands of Himalayan balsam are searched for throughout the season and locations noted as they are identified. Once located, several methods can be employed to tackle the issue, but for them to be effective they should be undertaken before the plant flowers.

The simplest method is to organise working parties to undertake periodic balsam pulling events, which should occur before the plants have flowered. Pulled balsam should then be composted well back from the high water line. Alternatively, if a strimmer is available, this can be a useful tool for tackling larger areas of balsam, but may need undertaking several times in a year. If a strimmer is used, it is important to hit the plant below the 1st node to

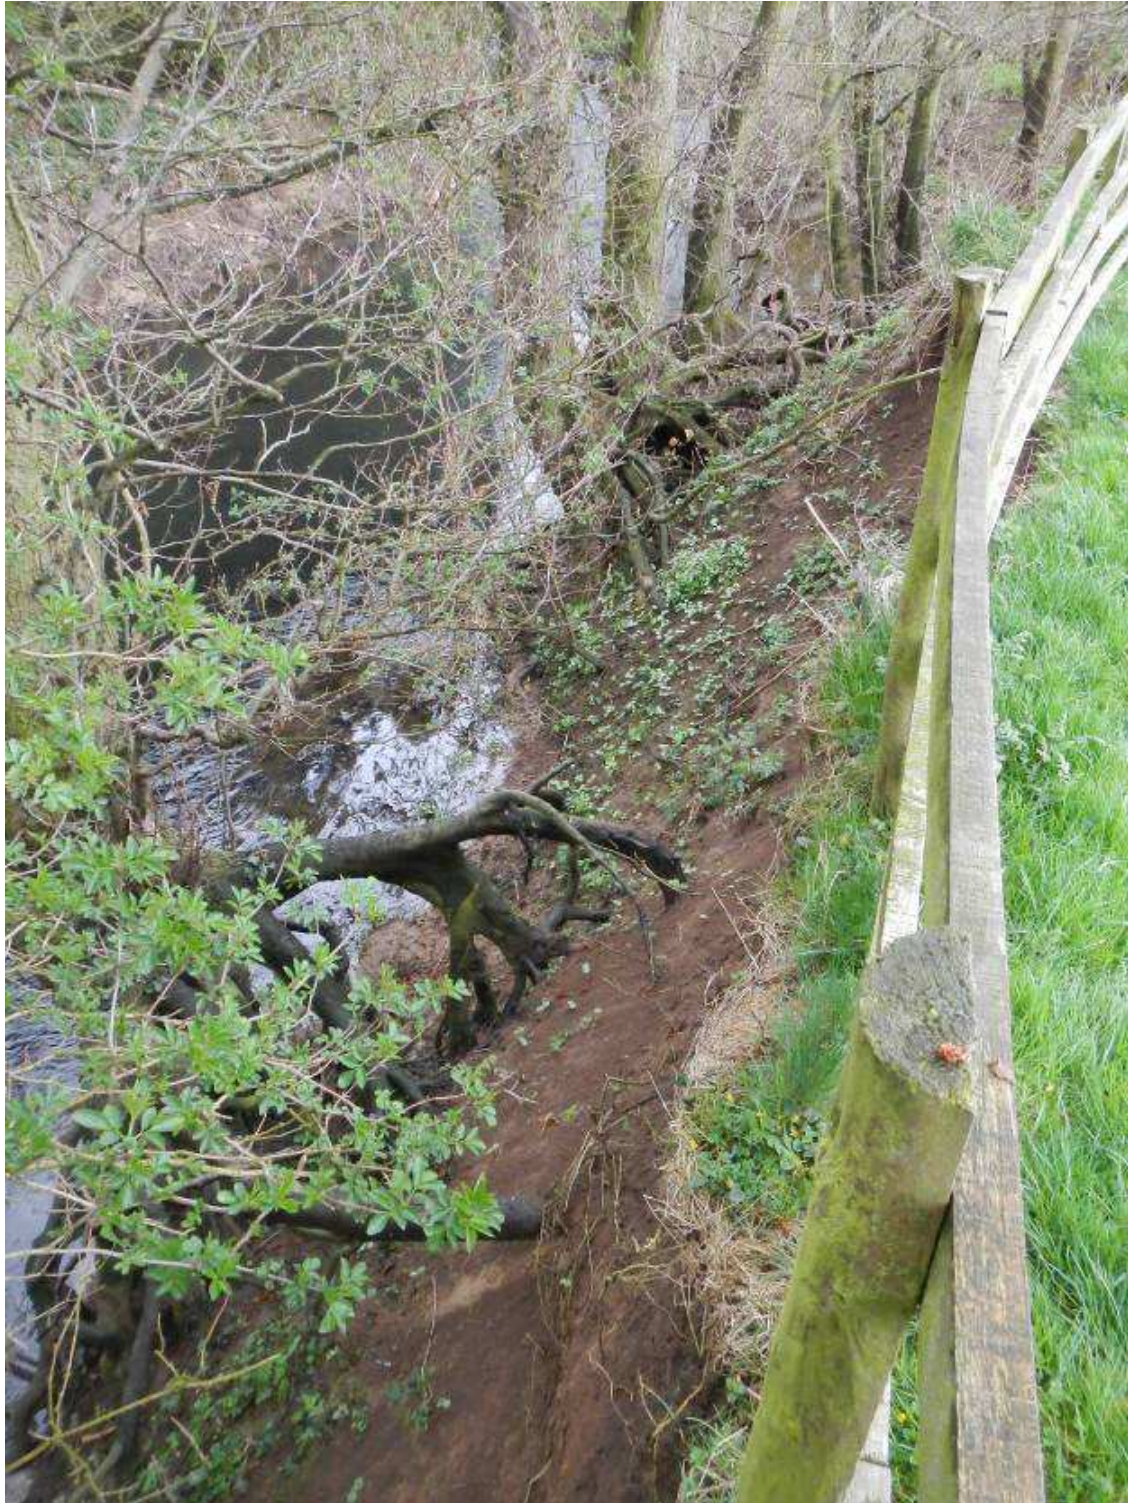
Figure 10. Large area of bank, largely devoid of vegetation almost certainly due to previous out-competition from of Himalayan balsam (NGR - SE4368279935).

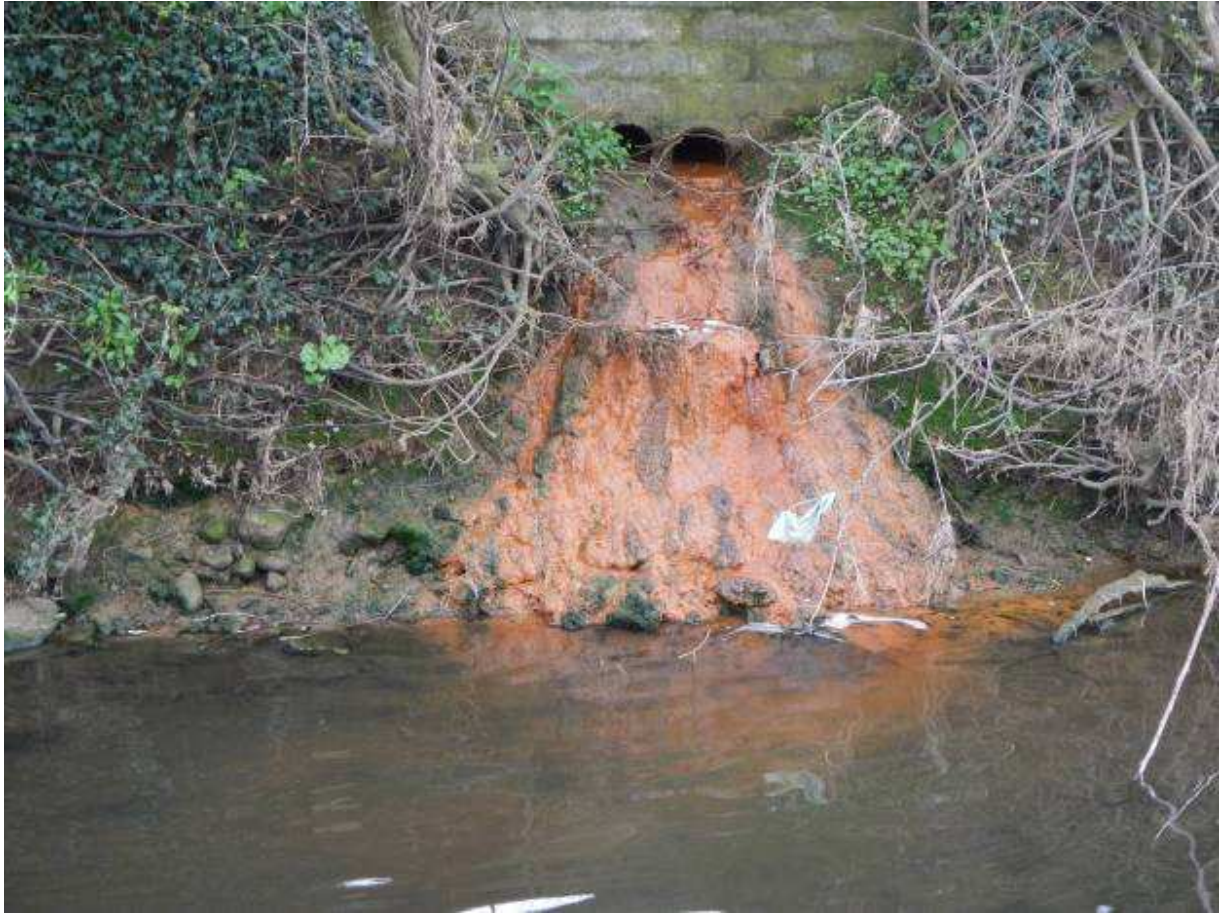
Two notable discharges are also present within this section, both in the same location, but likely of different significance. The most noticeable of these issues was a piped ochreous discharge (Figure 11). Without detailed chemical analysis it is not possible to ascertain the toxicity of this, and although metalliferous discharges can have a negative impact upon pH, increased sedimentation, deposition of metals, and dissolved oxygen (through oxidation of the ferrous minerals), the volume of this discharge was very low and appeared to have a minimal impact within the Beck; unlike that of many higher volume discharges on other watercourses, where the impact can be observed for several tens of meters.

Figure 11. Metalliferous (probably hydrated iron oxides) discharge assumed to be from an old gravel working (NGR - SE4360780276).

The ochreous iron oxide discharge is not expected to be a significant issue to the watercourse, but the discharge from the sewage works should be reported to the EA as a potential issue.

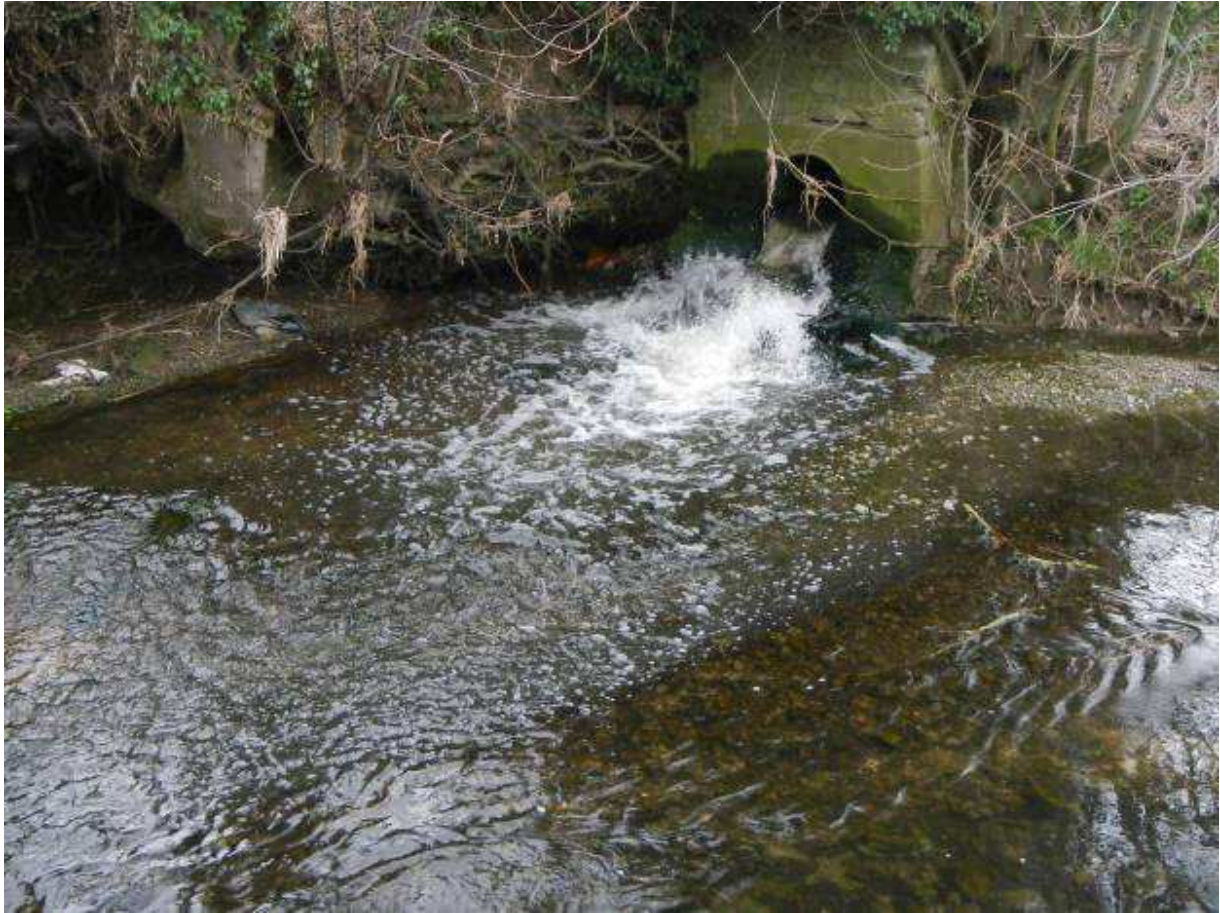
Very closely upstream, a sewage discharge did appear to be of potential concern (Figure 12). The noticeable grey coloured water and grey sewage fungus on the outfall cascade suggests a high nutrient content, and should be reported to the EA.

Figure 12. Grey water discharge from the sewage works (possibly elevated in nitrates and phosphates, however, little evidence of detergent contamination). This should be reported to the EA as a possible chronic pollution (NGR - SE4361180294).

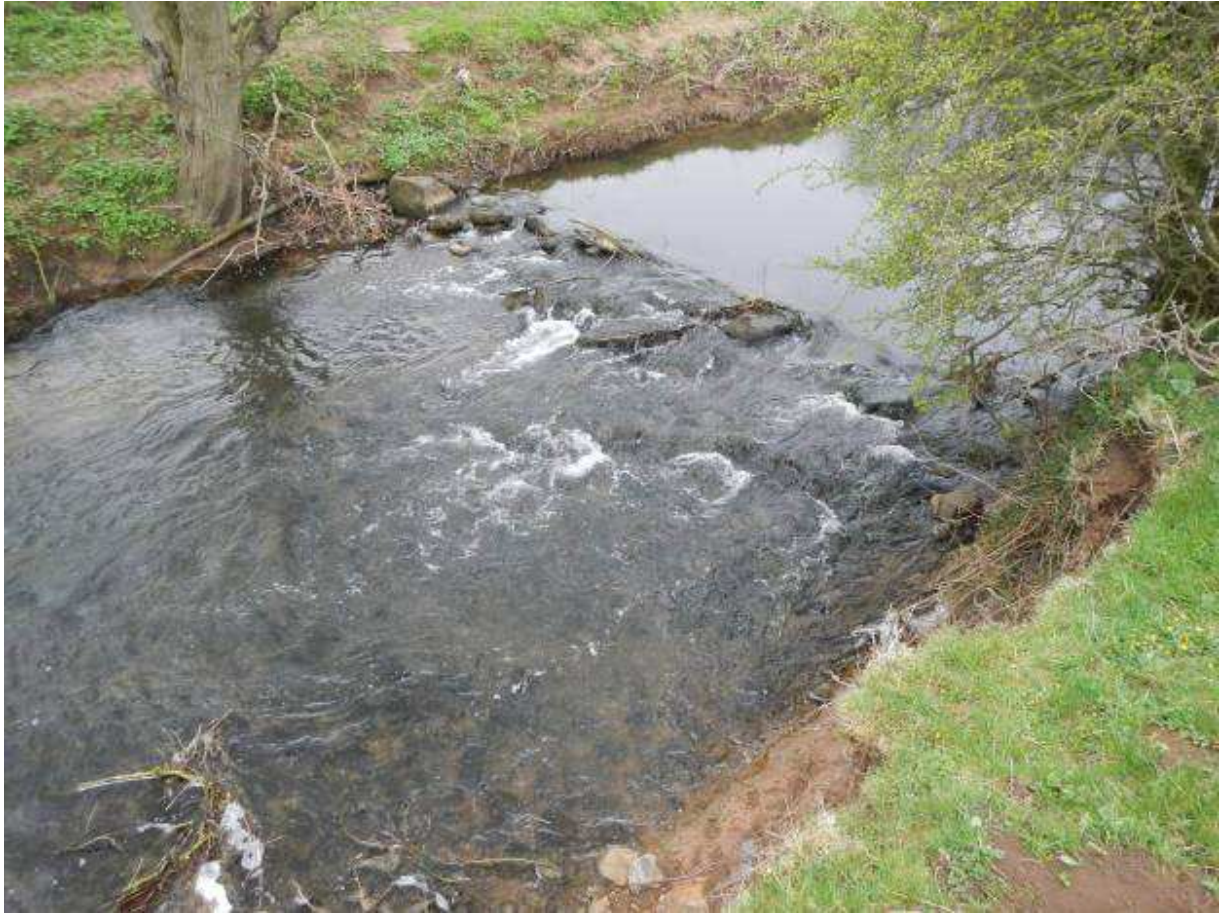
Several small weirs were also observed throughout the walkover (Figure 13). Most of these appeared to be past attempts to increase water depth and improve the conditions for angling on the Beck. In fact, weirs actually create an impoundment to flows, increasing deposition and ultimately lead to shallowing and habitat degradation. It is far better to employ the techniques described earlier to mimic and facilitate the natural processes within a watercourse, for example narrowing and promoting bed-scour, rather than impounding channels. Driving the river-bed down creates self-cleaning pools and preserves riffle habitat. In contrast, holding water up to create pools causes sedimentation, stagnation and drowns out valuable riffle habitat. With this in mind, it is advised that wherever weirs are present, sections of the weir are removed down to bed level, increasing scour in the focus areas created and improving hydraulic conditions.

Figure 13. Small weir downstream of the A168 (NGR - SE4367880518). Removal of 400-500mm of width in the central area down to bed level, on this and other similar weirs would be very beneficial.

Although there are no major barriers within the Beck reaches walked, it is strongly recommended that the central sections of all weirs on the watercourse be reduced to bed level. This will remove the impact of flow impoundment upstream, allowing more natural flow diversity and increasing beneficial bed scouring.

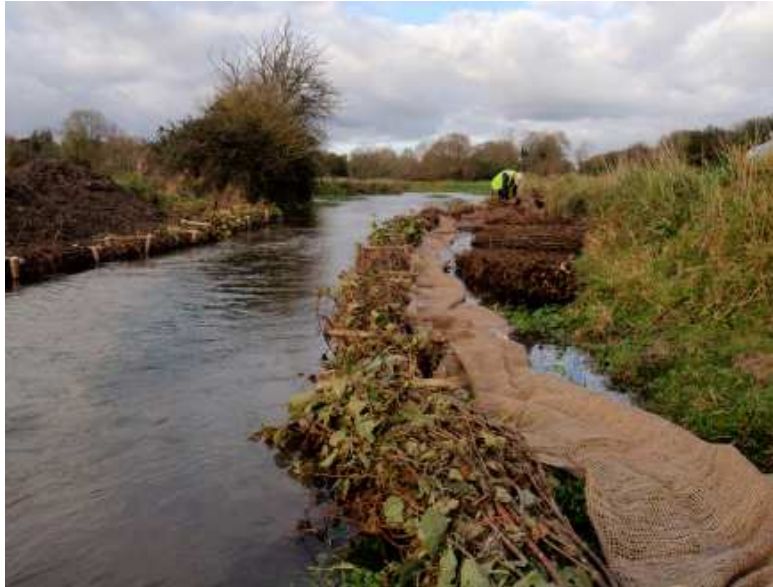
Figure 14. Bank creation using willow faggots and brush backfill. This example also includes the use of hessian or coir.

In many of the over-wide, straight areas a new bank line could be created with living willow or hazel faggots. These would be staked into the bed to create a toe. The area behind the new bank line would then be backfilled with brash, to create a mattress, wired down to the bed with multiple stakes to prevent wash out (Figures 14 & 15). This method increases sediment deposition within the brash by baffling and slowing the flow over it. The example in Figure 14 also employs the use of hessian geotextiles to encourage deposition and protect the backfilled area until it becomes colonised by vegetation, although this is unlikely to be necessary.

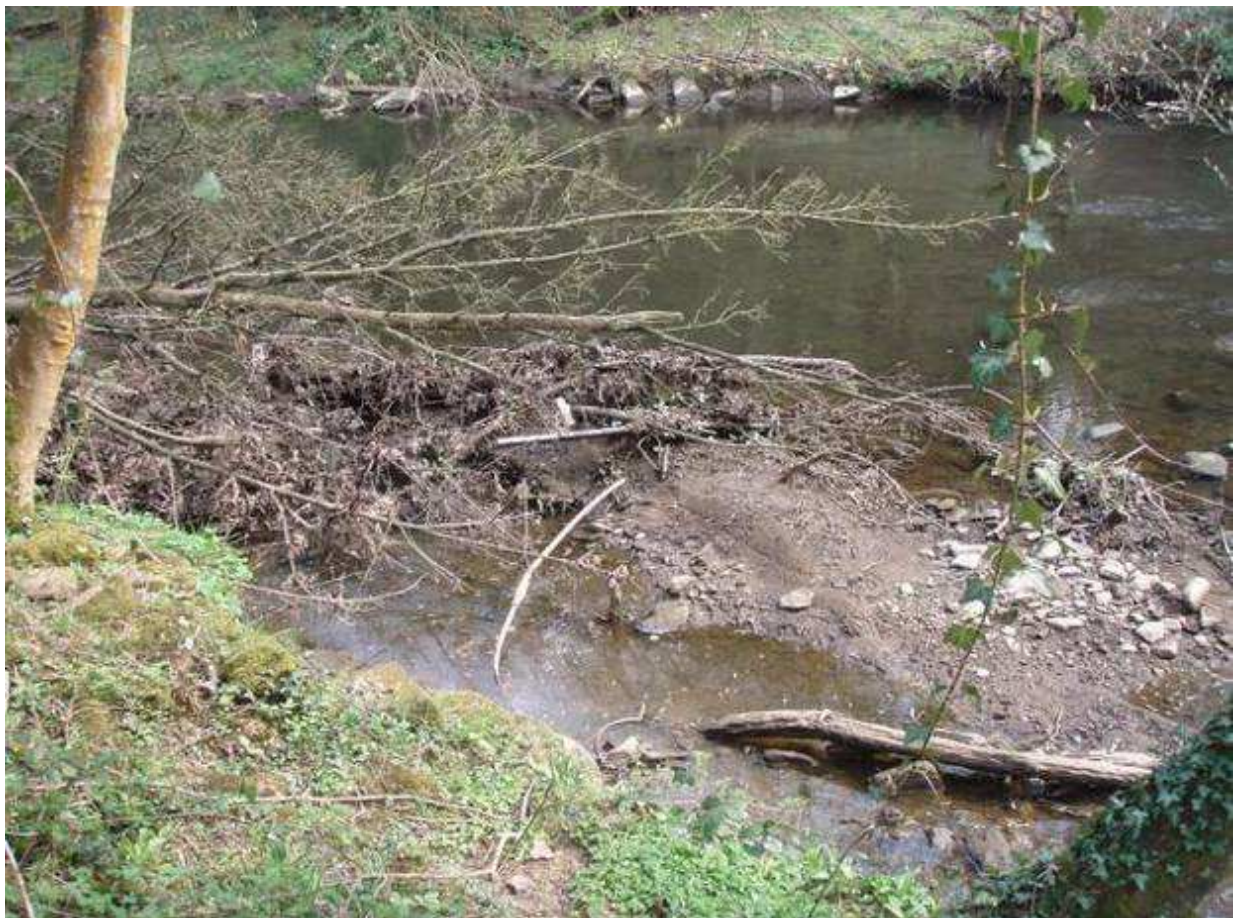
Figure 16. Note the narrowing effect through significant gravel and sediment accumulation (centre and right of shot) in the sheltered area downstream of the tree kicker.

Introducing LWD and structures like tree kickers (large branches, or whole trees anchored in place to produce cover and flow deflection) will concentrate flows to certain areas of the channel (usually towards the centre), scouring out deeper pool habitat while creating slacker areas within the margins where deposition will increase (Figure 16). Tree kickers can be easily secured in place with cables (Figure 17).

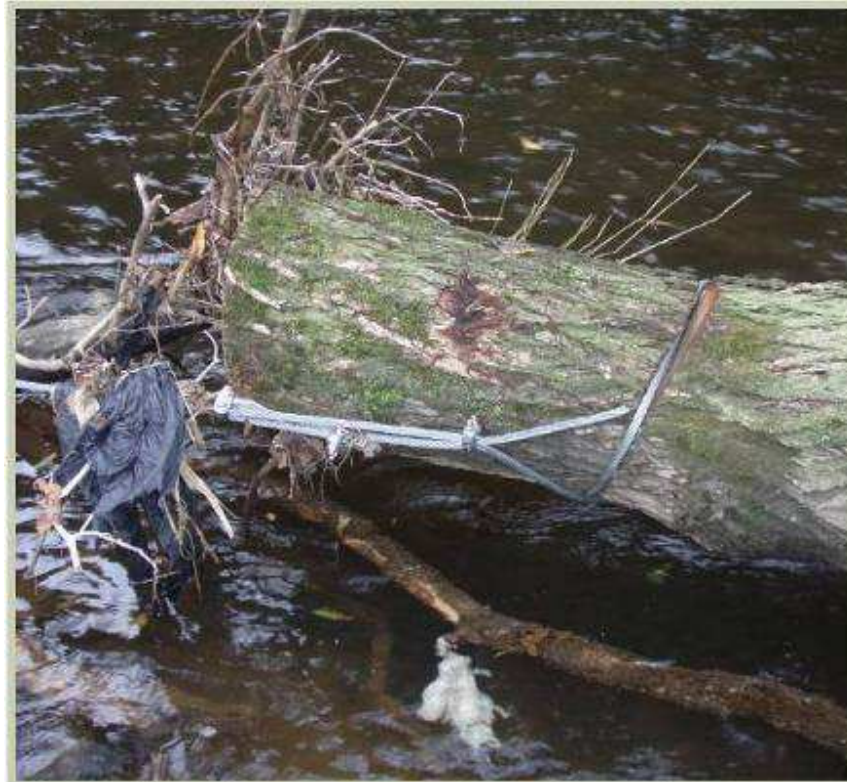
Figure 17. Cabling for a tree kicker.

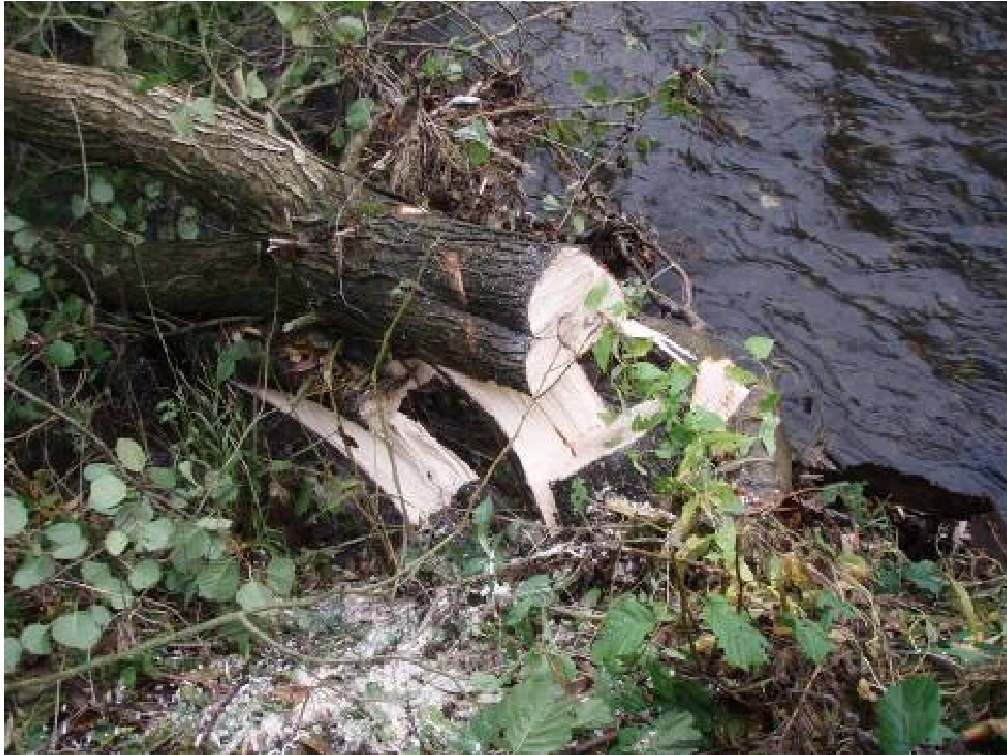
Figure 24. Hinged willow.

The process involves cutting part way through the stem/trunk (a bit at a time) until it can be forced over into the channel (Figures 24 & 25). Care

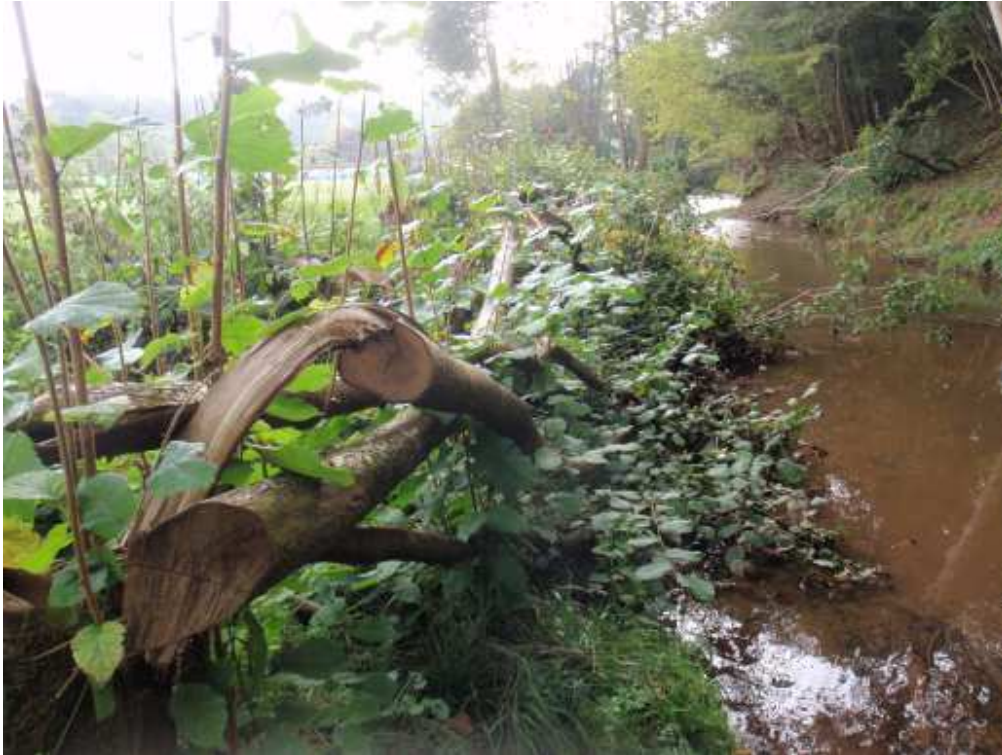
Figure 25. Hinged hazel.
